INDOOR AIR QUALITY ASSESSMENT

**Lanesborough Elementary School
188 Summer Street
Lanesborough, Massachusetts**

Prepared by:
Massachusetts Department of Public Health
Bureau of Environmental Health Assessment
Emergency Response/Indoor Air Quality Program
June 2003

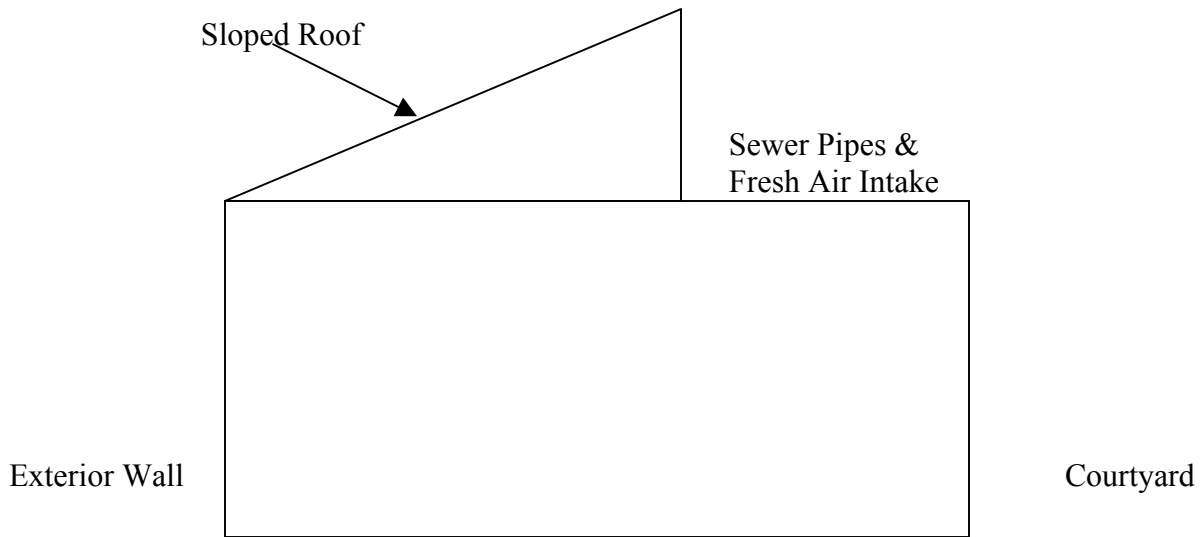
Figure 2

As mentioned previously, sewer gas odors were reported in some classrooms. In order to ascertain the source of such odors, an evaluation of rooftop equipment was conducted. Of note is the configuration of the roof. The roof has an upper and lower section. The upper section is formed by a sloped roof that is pitched towards the exterior wall of the building (see Picture 2). In place of a sloped roof pitched inward towards the courtyard on the lower section, a flat roof was installed (see Picture 3). The intent of this design is to prevent the diversion of rainwater from the roof into the courtyard. A number of building components are installed on the lower roof, including exhaust vents, fresh air intakes and sewer vent pipes. One classroom with reports of chronic sewer gas odor is located off the east wall of the courtyard. This classroom has its univent installed within the suspended ceiling, with the return vent located near the window. The fresh air supply for the univent is a roof vent gravity intake (see Picture 4). Located in the same vicinity of the gravity intake vent is a sewer vent pipe. Under certain weather condition characterized by heavy precipitation into the buildings septic system, pressurization of the system can force odors out of sewer vent pipes on the rooftop. Sewer gas is heavier than air and would be expected to sink toward the roof surface where it can be drawn into this classroom as the univent operates. A secondary pathway for sewer odors may be through this classrooms' windows system. Significant drafts were penetrating into the classroom around window frames at the time of the assessment.

**Configuration of Roof
(cross-section)**

1. An extension of the sewer exhaust vent several feet above the fresh air intake may be needed to prevent sewer gas entrainment. The building code requires that pollutant sources must be ten feet away from and two feet above fresh air intakes (BOCA, 1993, SBBRS, 1997).

2. Render the window frame in the courtyard classroom airtight to prevent odor penetration.
3. Seal the wall with an airtight material in the northeast classroom.

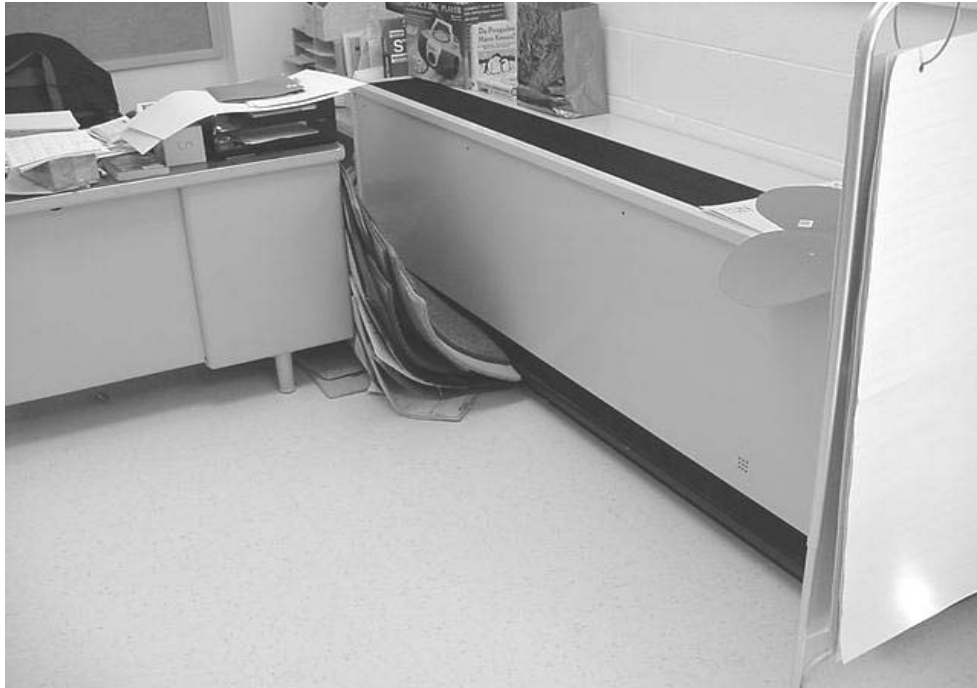
Picture 1

Carpet Squares in front of Univent Return Vent

4. Remove all blockages from univents.
5. For buildings in New England, periods of low relative humidity during the winter are often unavoidable. Therefore, scrupulous cleaning practices should be adopted to minimize common indoor air contaminants whose irritant effects can be enhanced when the relative humidity is low. To control for dusts, a HEPA filter equipped vacuum cleaner in conjunction with wet wiping of all surfaces is recommended. Drinking water during the day can help ease some symptoms associated with a dry environment (throat and sinus irritations).

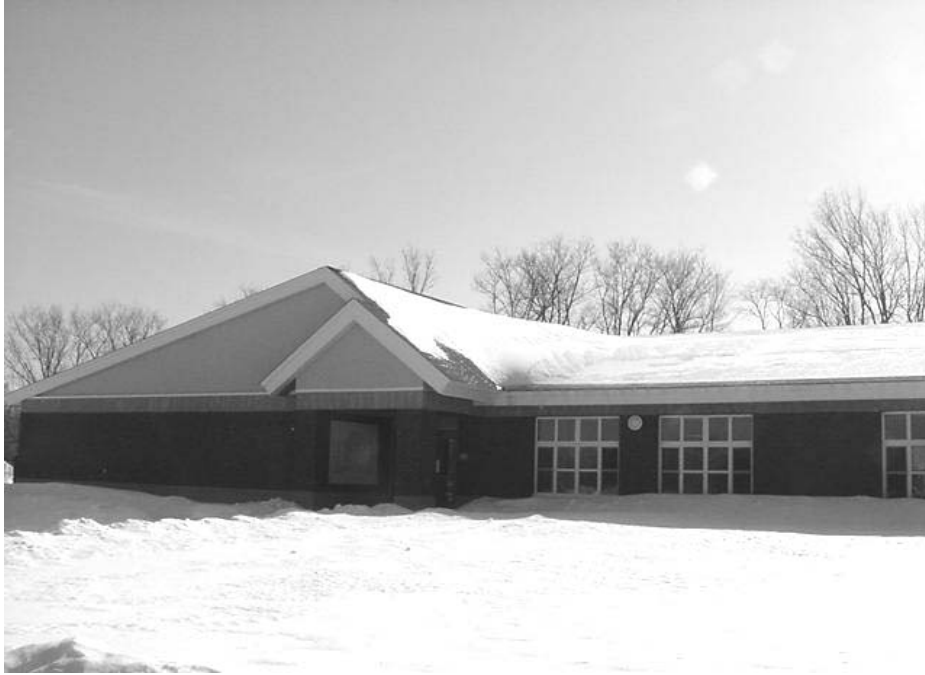
Picture 2

Roof Section Sloped towards Exterior Wall

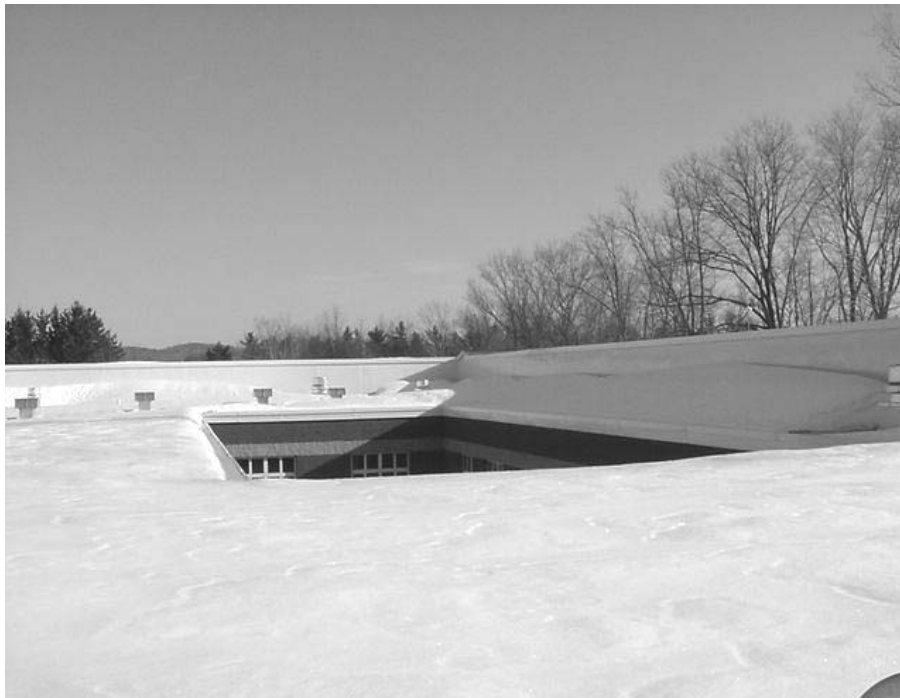
Picture 3

Flat Roof Adjacent to Courtyard

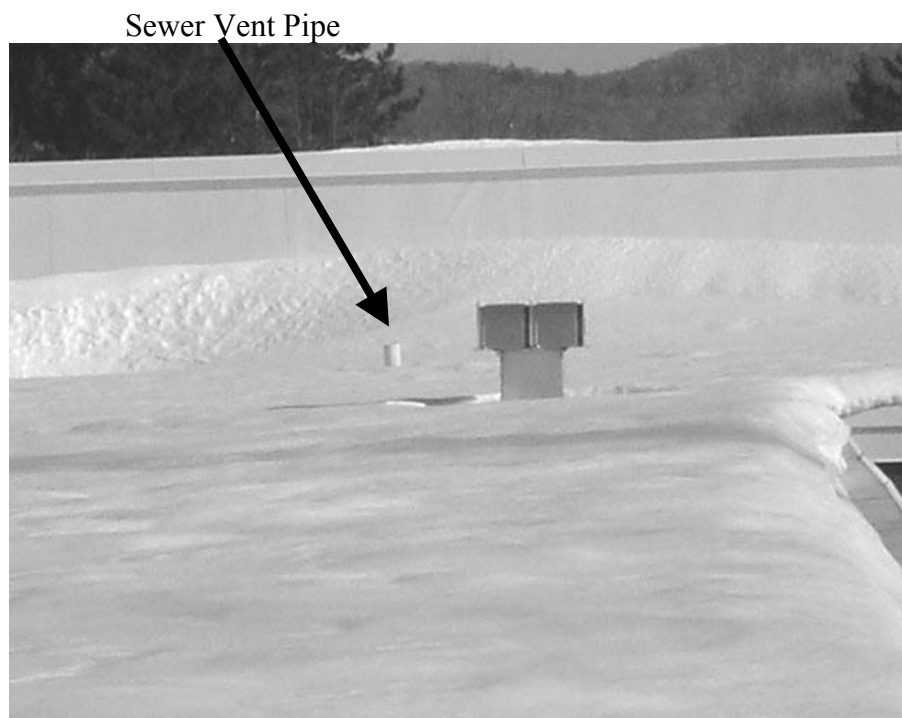
Picture 4

Penthouse Roof Vent Gravity Intake, Note Location of Sewer Vent Pipe *below* Level of Fresh Air Intake

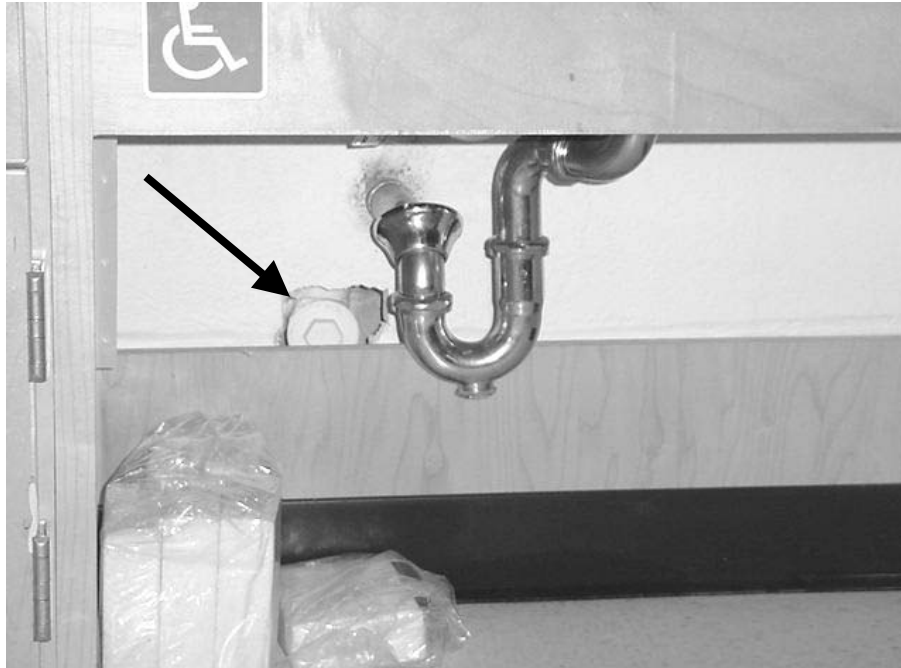
Picture 5

The classroom located in the northeast corner of the school also reported sewer gas odors. An open section of interior wall was noted underneath the classroom sink (see Picture 5). If the septic system becomes pressurized, a leak in the plug or seam in the pipe may force sewer odors into this classroom.

Open Section of Interior Wall with Drain Pipes underneath the Classroom Sink

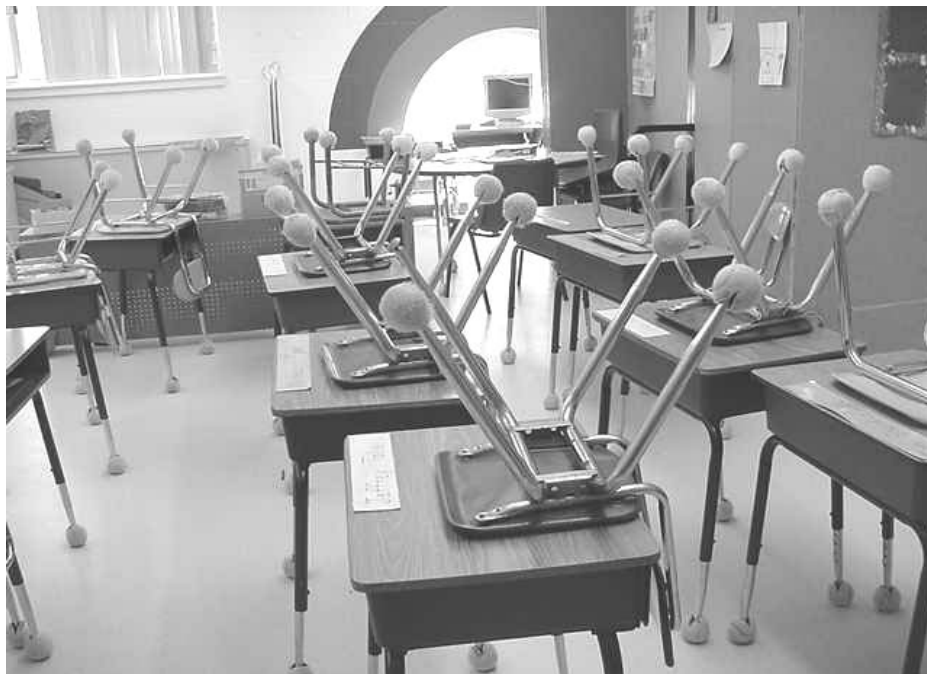
Picture 6

In an effort to reduce noise from sliding chairs, tennis balls are sliced open and placed on chair legs (see Picture 6). Constant wearing of tennis balls can produce fibers and result in off gassing of materials. Tennis balls are made with a natural rubber latex bladder, which becomes abraded when used as a chair leg pad. Use of tennis balls in this manner may introduce latex dust into the school environment. Some individuals are highly allergic to latex (e.g. spina bifida patients) (SBAA, 2001). It is recommended that the use of materials containing latex be limited in buildings to reduce the likelihood of symptoms in sensitive individuals (NIOSH, 1997). A question and answer sheet concerning latex allergy is attached as [Appendix II](#) (NIOSH, 1998).

Tennis Balls on Chair Legs

7. Discontinue the use of tennis balls on chairs to prevent latex dust generation.
8. Pour water down drains to eye wash stations once a week (or more frequently if needed) in science rooms to prevent the drying of traps.
